Identifying Management Areas and Controls for PCBs in San Mateo County Stormwater

Jon Konnan - EOA, Inc.
C/CAG Stormwater Committee

August 18, 2016

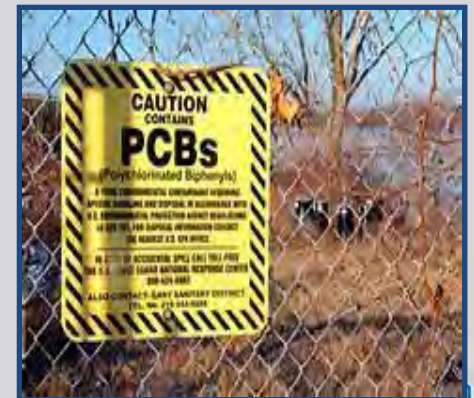
April 2016 Progress Report

- Based on sediment results to-date
 - Two confirmed WMAs
 - Eight potential WMAs
 - Remaining catchments with parcels of interest but no elevated sediment samples or no data.
